Chlorine Trifluoride

Aug 2021

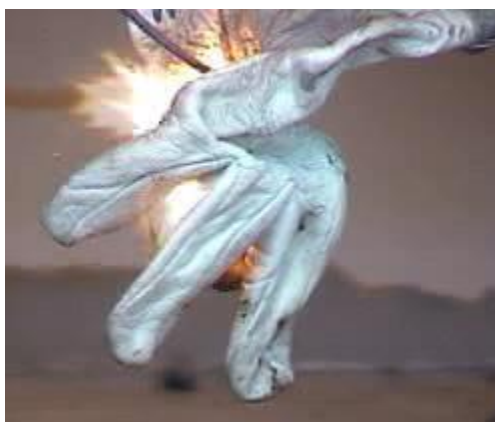
Fig 1: ClF_3 Gas and New Leather Gloves

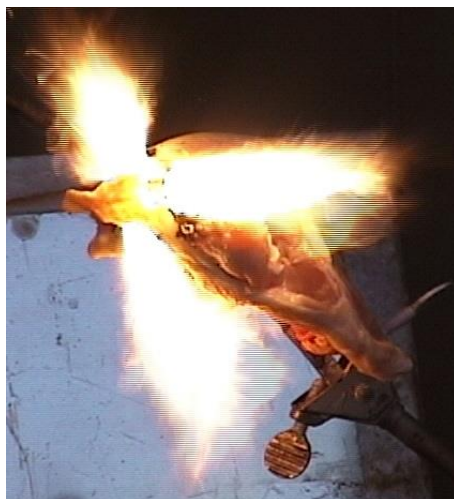
Reaction with oils is violent. Vapor reaction with raw chicken skin is intense. Liquid is explosive.

Fig. 3: ClF_3 Vapor and Raw Chicken

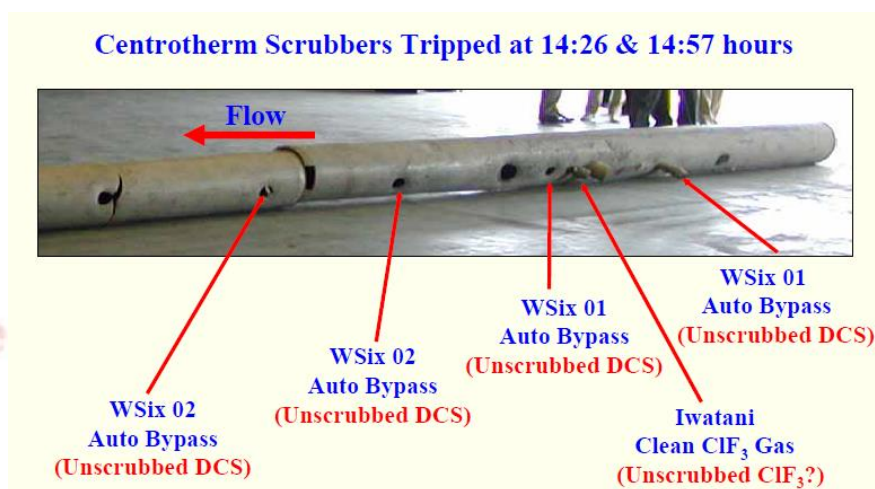
User, Taiwan, 1997

Venting of 0.3% DCS and 0.3% ClF_3 reacted in vent duct, Fire burned down the facility

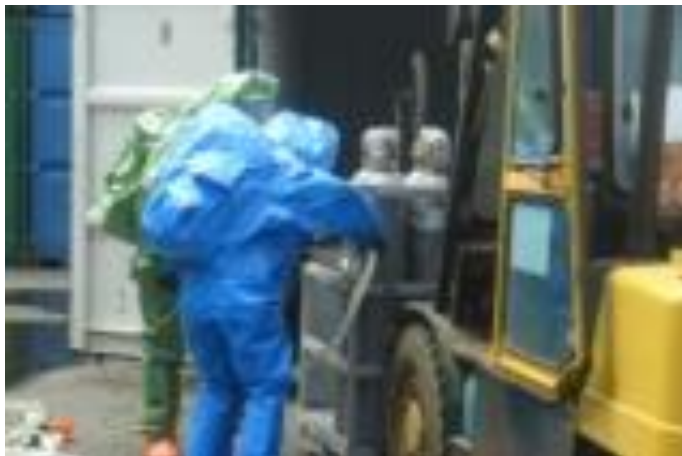
Ship Port, Korea, 2007

Residue ClF_3 cylinders being returned to supplier in Japan. A port in Ulsan there was a report of white cloud from 2 cargo containers (ClF_3 and DCS)

Found 4 ClF_3 cylinder valve handwheel and vaportight outlet cap loose.

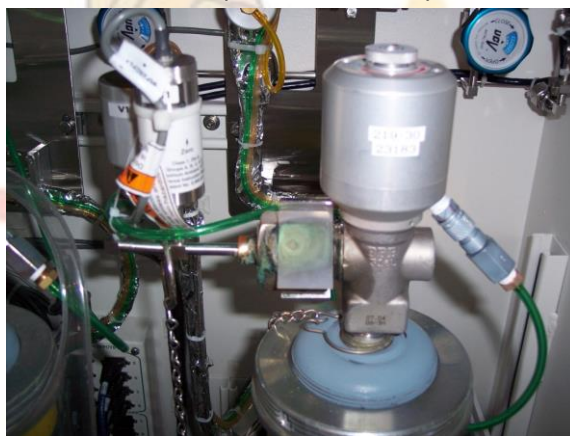
Gas Cabinet Leaks, Users,

Most leaks react and damage all no metal components that they touch. No catastrophic failures

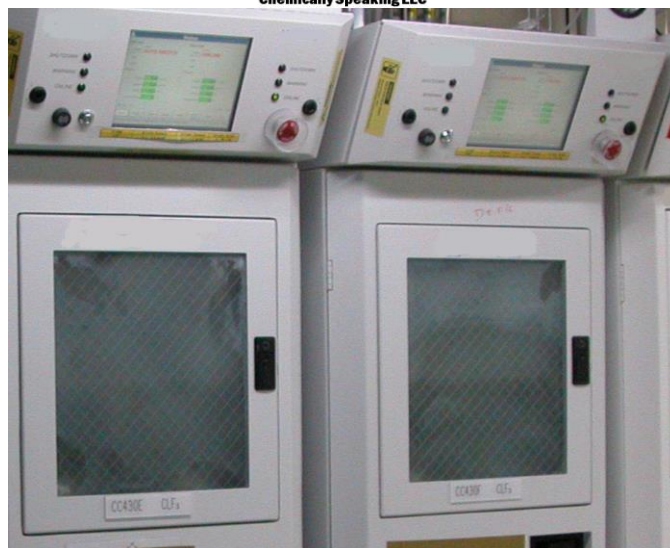
If the ClF_3 release is large enough it will etch glass such as the gas cabinet window, making it difficult to see the gas panel.

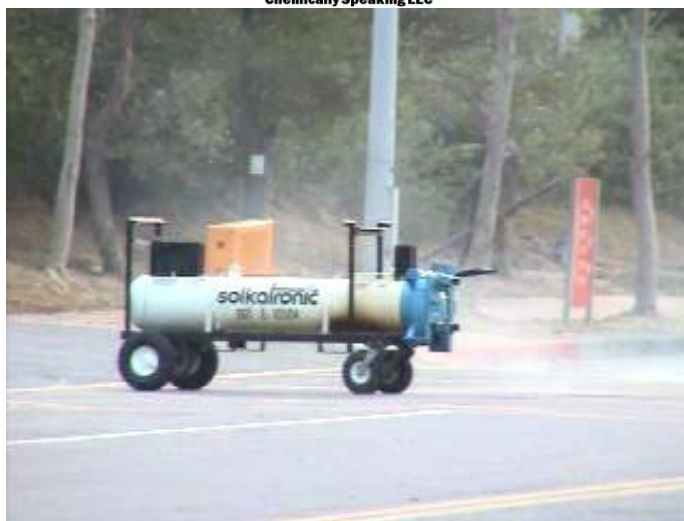
Use a Non Passivated ERCV, Taiwan, 2004

In Jan 2004 a Fab ER Team starting up a new 300 mm Fab used a new 5502 ERCV to contain a ClF_3 cylinder that they didn't realize had the valve wide open on the cylinder. Use of a ERCV for strong oxidizers like ClF_3 is prohibited by the procedures since the ERCV cannot be cleaned and passivated. As the flange was being closed the ClF_3 immediately started to react with the O Rings and Seal. The ER Team panicked and pushed it out into the parking lot where the leaking ClF_3 liquid proceeded to burn a hole through the carbon steel. The reaction was so hot that it charred the epoxy paint.

ERCV With ClF_3 Liquid Reacting With Carbon Steel
