Solkatronic Chemicals Silane CG-4 PRD Incidents

Date: May 14, 2009

To: CGA G-13 Task Force

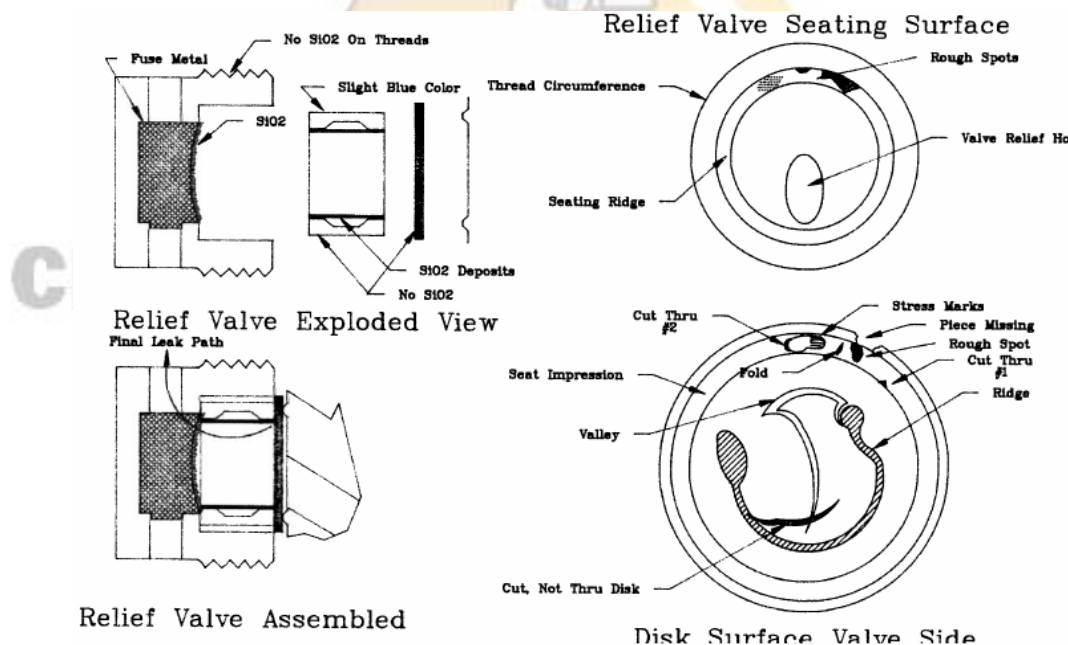
On April 17, 1989 a pure silane cylinder at a customer site in Phoenix, AZ started to leak at the PRD when the valve shrink wrap was removed. This ignited, producing a small flame. The site ER team quickly vented and inerted the cylinder. This was a new cylinder and valve that was filled on Jan 13, 1989. The valve was a pneumatic valve which was of a new design. It had a unique PRD assembly which compressed the metal rupture disk against a polished bead (seating ridge) machined into the valve body.

This valve was taken apart at the valve manufacturer and visually examined. It was concluded by the investigation team that the polished bead was poorly polished and inspected. As the rupture disk was being compressed against the valve body, the disk rotated against this rough surface causing 2 tears. The fuse metal held back any gas leakage for a number of months. It started to cold flow and slowly pushed the fuse metal out of the PRD collar and then continued extruding at the vent holes until it started to leak.

Other valves from this batch were removed from other filled silane cylinders and examined, none had the same bead damage. The valve manufacturer modified his design and inspection procedures and there were no further PRD problems. This valve design is no longer being made.

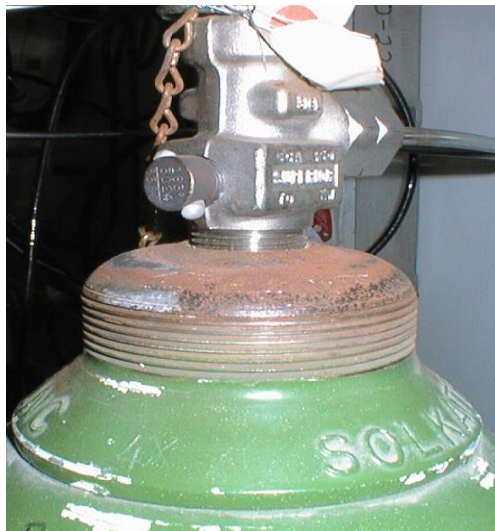
3 Diborane mixture leaks at customer sites which triggered emergency responses in 1993 & 1995 were all examined by the valve manufacturer. All had extruded fuse metal (see picture) and fully cracked rupture disks. The engineering report suggested that the cause of the cracks was due to fatigue.
