Y Cylinder is a Robust Package

July 2022

To determine if dropping a Y cylinder could cause it to leak. A height of 8 ½ ft was selected since I had authorized 3 high rack storage for them at Air Products.

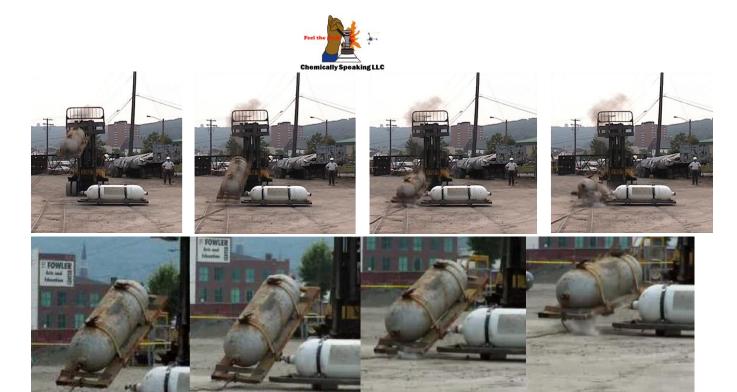
Second dropped Y hit valve handle with skid front forklift channel. This damaged the valve causing a leak.

The dropped Y bounced back and hit the valve again which caused the dropped Y to flip over

Y Hits Valve before the ground

Y Hits the ground

Y Pivots and Hits Valve Again

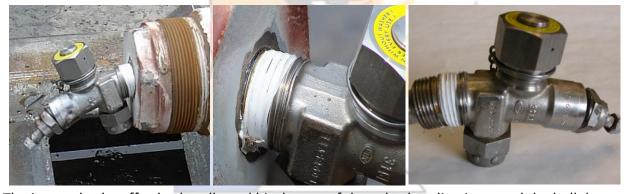
The impact broke off valve handle and hit the top of the valve bending it toward the bullplug. This pulled out the diaphragm nut causing a leak.

Since the Y was still pressurized with Nitrogen, the water came out immediately from the leak check port and diaphragm nut

Valve cracked at the threads but not through to the inner bore
The PRD stopped the bending, preventing the valve from cracking fully

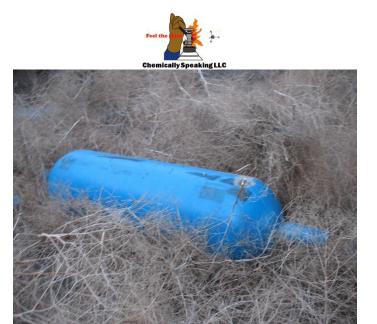
A gas supplier forwarded pictures of a NH₃ Y that was in a 40' trailer on a skid. The driver fell asleep and crashed through a guardrail into the side of a canal. The Y crashed through the bulkhead of the trailer through the cab and hit the concrete wall where it ricochets out of the trailer and down the canal embankment. It only suffered minor scratches, no leak.

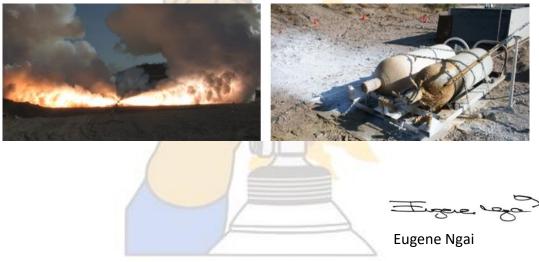
Even in the 2011 testing with full flame impingement from a silane Y PRD did not heat the adjacent Y filled with N₂ hot enough for it to rupture since the time was less than 3 minutes.
