Cylinder Leaks, Ngai Rule of Thumb

Compressed gas leak rates based on soap solution leak detection:

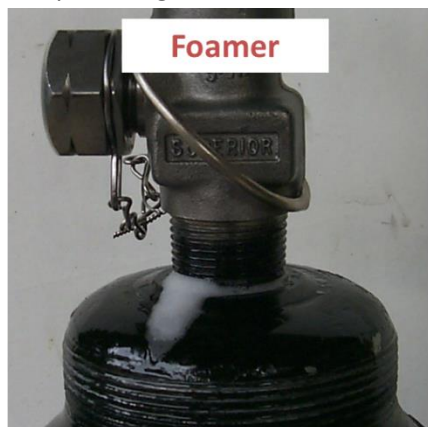
the smallest leak rate detectable by Soap solution is approximately 0.1 cc/min. Can take a few minutes to form after application

Figs 1-3: Leak Rates

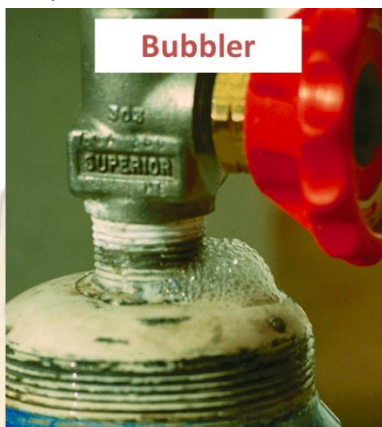
**0.5 to 10 cc/min
Continuous clear bubbles > 1 cm dia.**

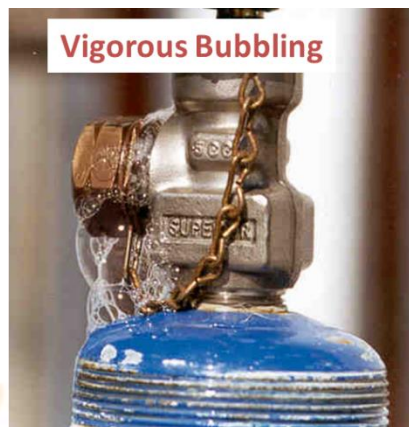
10-50 cc/min with the formation of large bubbles.

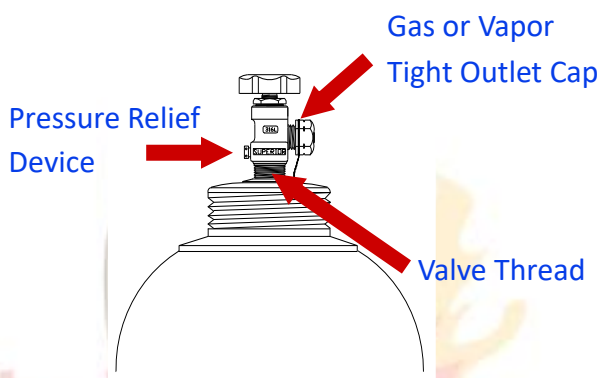
Fig 4: Cylinder Leak Points

Most likely leak points on a cylinder

The black arsenic is due to the hydrolysis of arsine. This leak was not detected using a paper tape detection system at 5 ppb since it was a ppt leak. Since a leak could be from any point as noted above, the only way to detect this leak was to cap the top of the cylinder, wait a short period of time and sample.

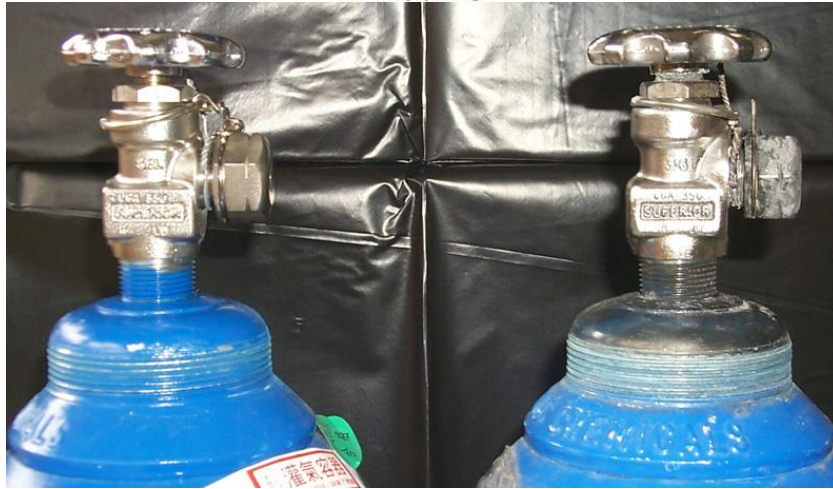
Fig 5: Clean Cylinder Left, Cylinder with PPT leak Right

A ppt arsine leak was only determined due to a visual inspection in 2001 for a pure arsine shipment to Taiwan. Use of a highly sensitive arsine leak detector did not pick up the leak. See *Metal Hydride Gas Cylinder Leakcheck* for details.

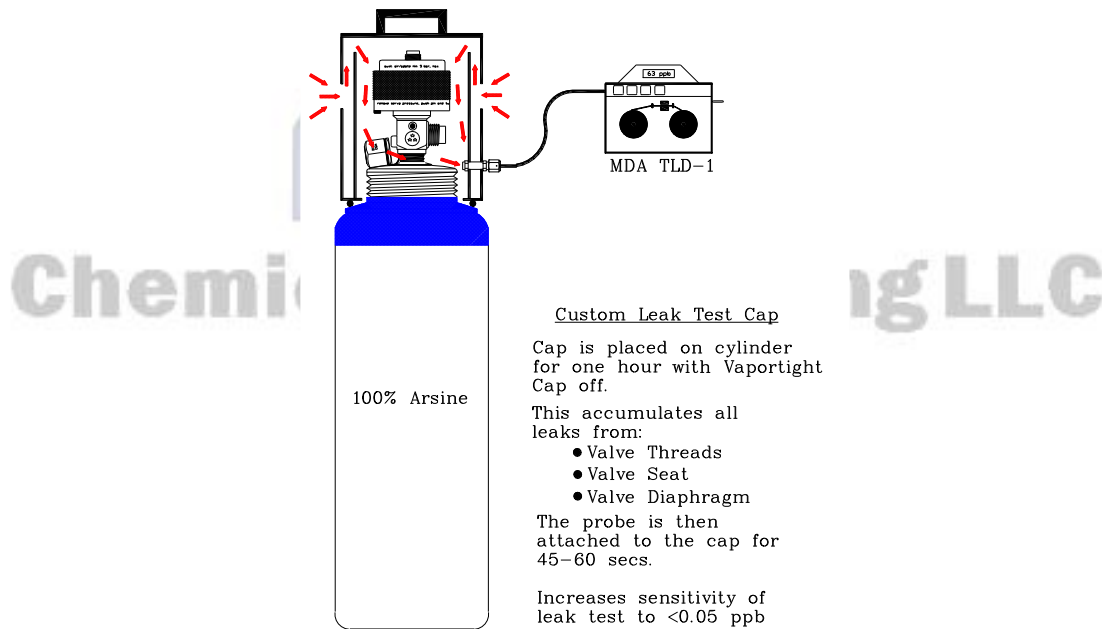
Many gas suppliers will use a custom cap to test metal hydride gas cylinders prior to shipment. This policy was practiced by Solkatronic Chemicals for all metal hydride shipments since 2000. Any detection was cause for rejection.

Fig 6: Solkatronic Metal Hydride Gas Leak Test

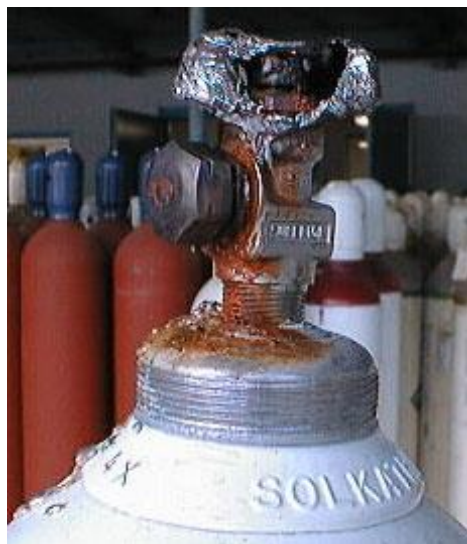
Phosphine leak and fire forms red phosphorus

Fig 7: Phosphine Leak and Fire
