Cylinder Valve Drop Testing Without Cylinder Cap from 7'

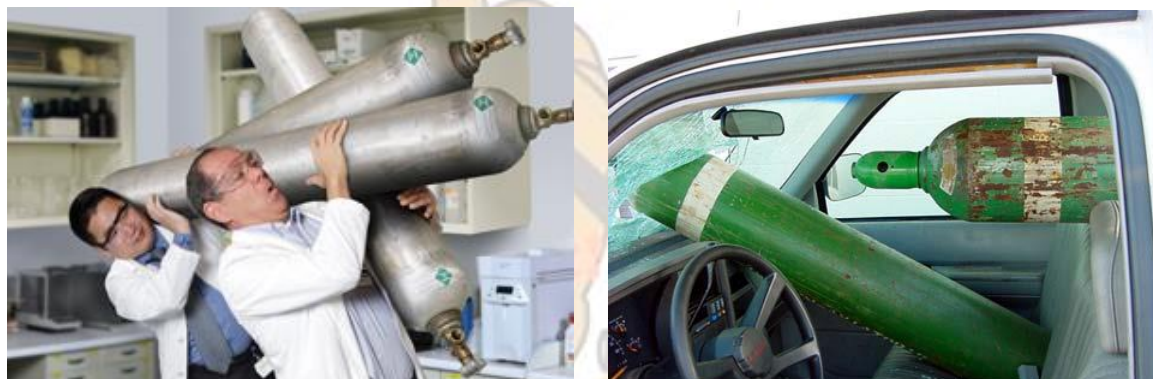
Figs 1 & 2 Unsafe Cylinder Handling, no cap and with cap

Cylinders must be handled properly to prevent leakage or damage to the cylinder valve

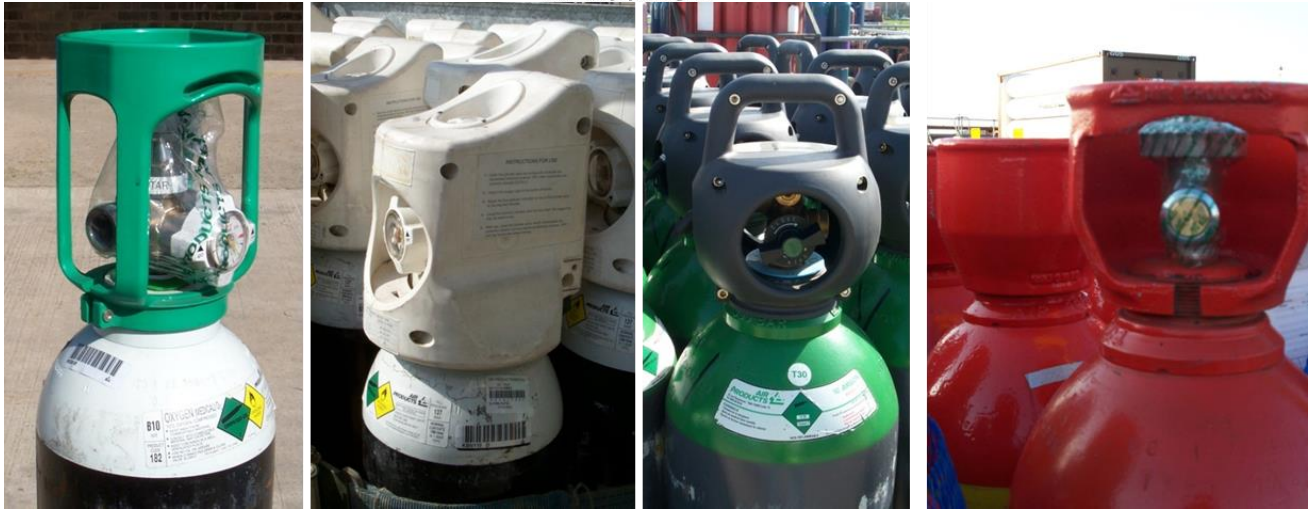
Polycarbonate Cylinder Valve Cap

Plastic valve guards are also used for many medical and calibration gas cylinders. This provides the convenience of not having to remove and reinstall the cylinder cap before and after use.

Valves had to be protected from damage.

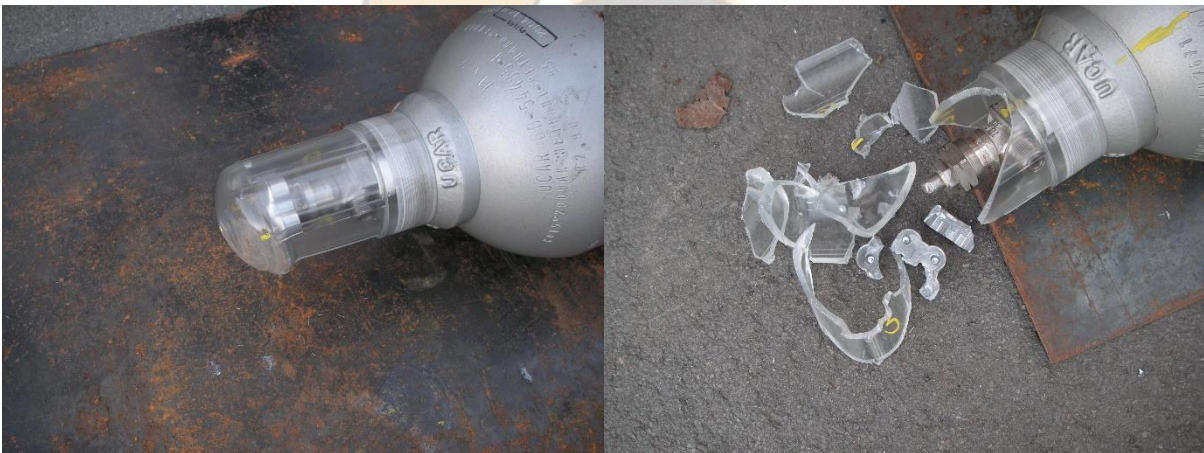
Figs 3 & 4: Polycarbonate Cylinder Cap Drop test

Apragaz a Belgium Testing Organization like United Laboratories (UL) conducted testing of a polycarbonate Cylinder Cap using the European National Standard, EN962 TEST PROTOCOL Drop Testing

- a) 6 times at ambient temperature, rotational test at increments of 60 deg to axis of valve outlet connection
- b) 1 time at -20°C
- c) 1 time at $+65^{\circ}\text{C}$

In each case the cylinder was dropped from a height of 1.2m and at 30° to the vertical. The cylinder is dropped onto a steel plate 1 m square.

Typical of 136-150 lbs with water added for a total cylinder weight of 253 lbs

In no case did the valve leak

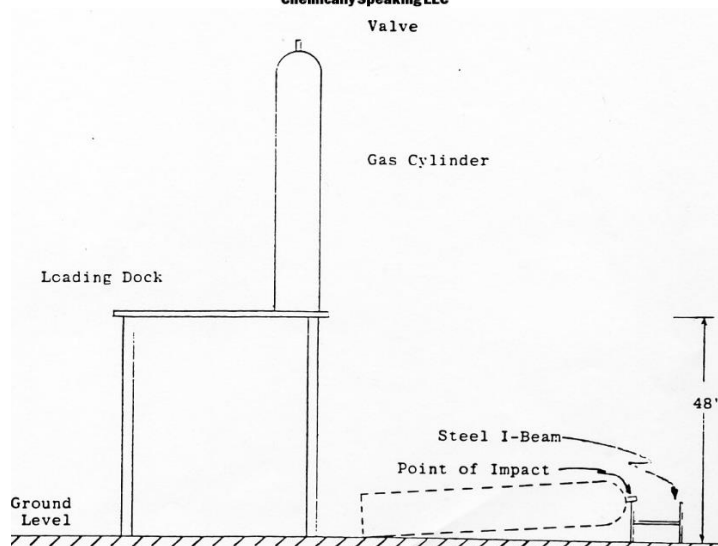
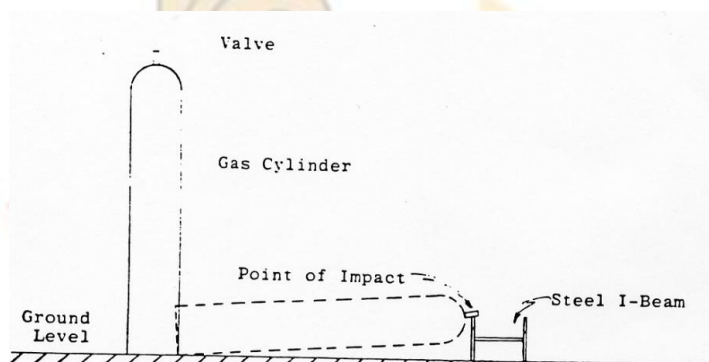
In 1985 Bell Communications Research contracted Hazards Research Inc. to conduct a study on gas cylinder valve impact.

| Cylinder Size | Valve | | |
|---|---|--|---|
| 44 liter | Brass | Dropped with cylinder cap on from the dock, no damage to valve Dropped 2 times from dock without cap, valve hit ground, no damage The 3 rd drop it hit the I beam and the bonnet nut cracked, valve was bent 3/4" | Decided it was not safe to do leaktest |
| 44 liter | Stainless | Dropped 2 times from dock without cap, valve hit ground and then hit I beam, no visible damage The 3 rd drop it hit the I beam and, valve was bent 1/2" | Slight leak at valve threads into cylinder visible with soap solution |
| 44 liter | Stainless | Tipped over without cap, hit I beam. No visible damage | No leaks observed |
| 16 liter | Stainless | Tipped over without cap, hit I beam. No visible damage | No leaks observed |

| 16 liter | Stainless | Cylinder was dropped from dock twice with cap on, hit the ground first and the I beam second. No visible damage to cap or valve. Dropped twice without cap, both times hit I beam. No visible damage to valve | No leaks observed |

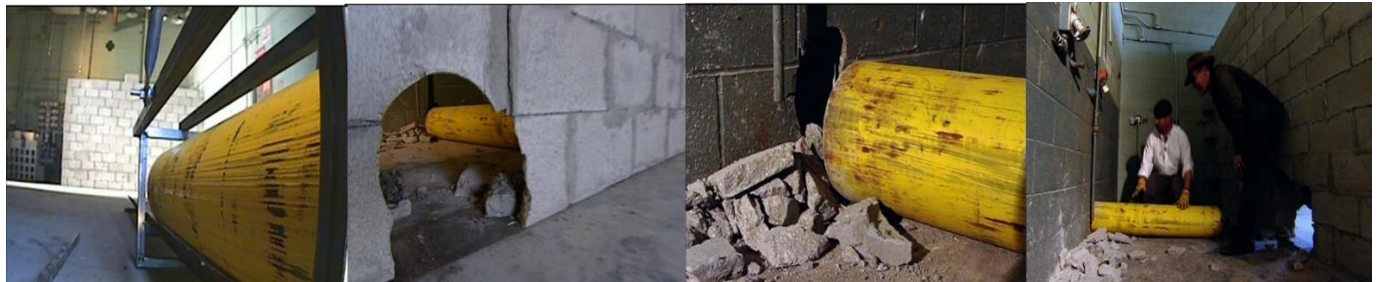
Fig 7 -10: Cylinder Impact of Concrete Block Wall

The first time they tried they only cracked the valve, They had to build a more robust guillotine.

140 lb cylinder

Brass Valve

>>40 lb weight dropped from 10'

Concrete block wall, 8", 20 ft from cylinder

Greased metal channel

Cylinder impacted at 40 mph

Moved Concrete Block wall 1/2" back

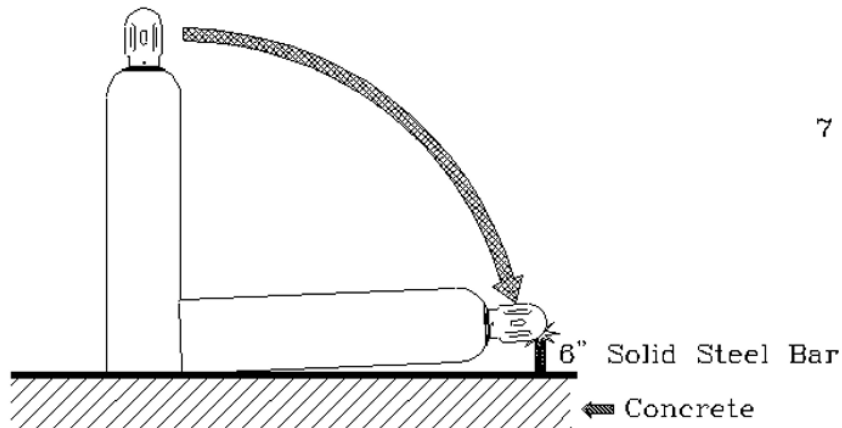
Fig.12: Tip Over Onto 6" High Metal Bar

Old Method
49 CFR 173.327 (a) (2)

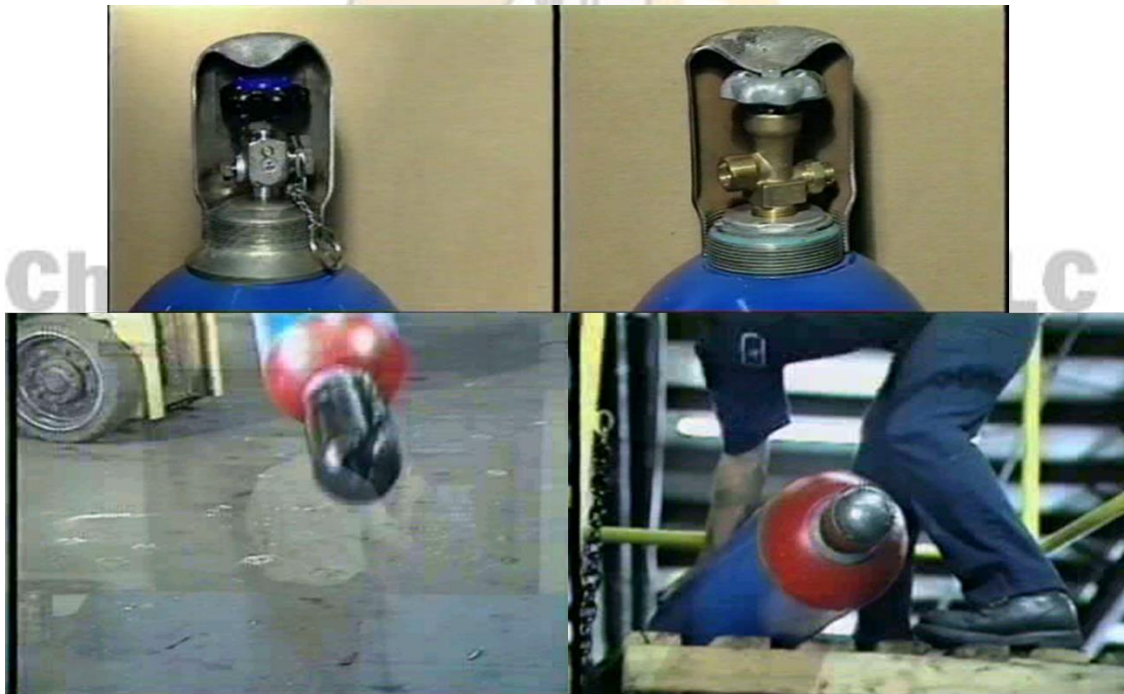
Fig.13: American Cylinder Cap Testing, One per batch is Dropped

Normal impact testing American Cap Corp from 7'. One dropped per batch. Cap must be easily removed, valve must be able to work and not leak.

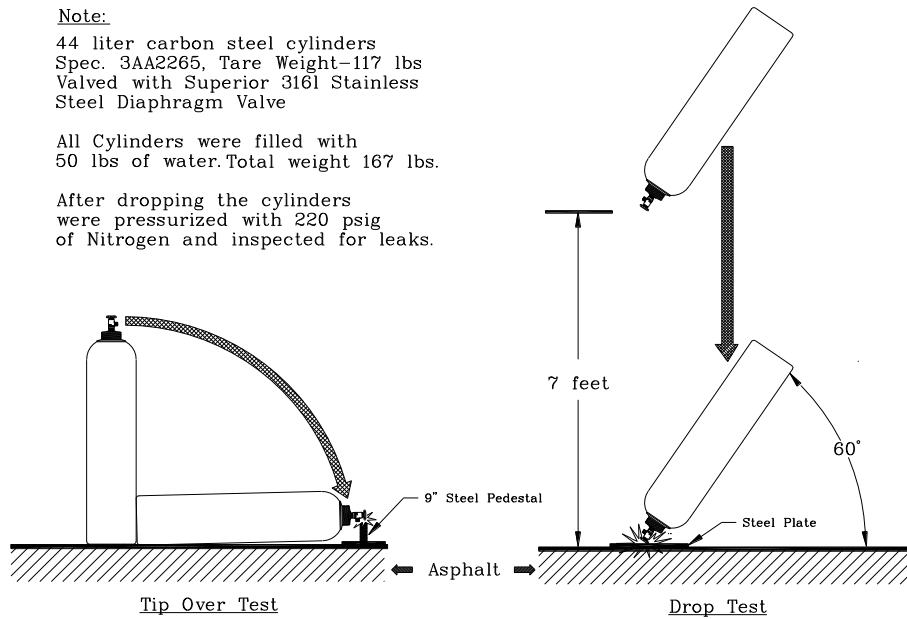
Fig 15: Drop Test No Cap

Four, 49 liter carbon steel seamless 3AA cylinders were tested each filled with 50 lb of water to simulate the weight of Arsine under normal conditions. These were valved with a 316L SS Manually operated spring-diaphragm valve from Superior Valve and leak tested. These were dropped using a special bracket that positioned the cylinder at a 60° angle to the ground which is estimated to create the maximum possible impact force. Impact was onto a ½ inch, carbon steel plate laid flat onto a asphalt surface. The drop test simulated the DOT requirement, which is from 7 ft between the ground and the valve.

Immediately after the drop, the valves were visually inspected for evidence of damage. These were then pressurized to 200 psig with Nitrogen while positioned over a bucket on a scale, this would measure the leak rate as the water dripped out of the cylinder.

44 liter carbon steel cylinders
 Spec. 3AA2265, Tare Weight-117 lbs
 Valved with Superior 316l Stainless
 Steel Diaphragm Valve

All Cylinders were filled with
 50 lbs of water. Total weight 167 lbs.

After dropping the cylinders
 were pressurized with 220 psig
 of Nitrogen and inspected for leaks.

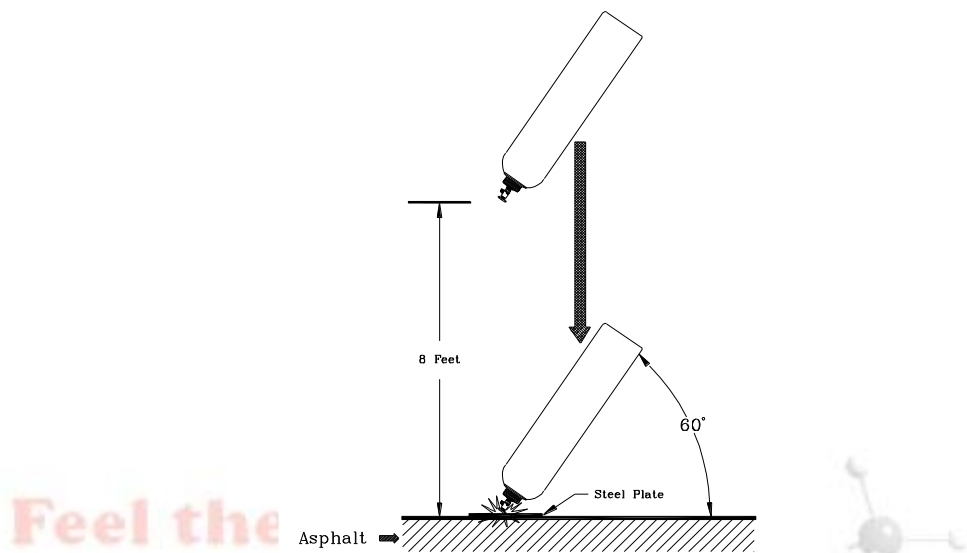
Fig. 18: Second Drop Test 2000

A second series of cylinder drop testing took place on 6/8/00. Two cylinders were valved with Superior tied diaphragm 316 stainless steel valves, CGA 330 with Safety. The cylinders were then leak checked to 500 psig with Nitrogen. (These were (2) previously used cylinders in the first series of drop tests). As in the first series of tests, metal shot was left in place in these cylinders. The pressure was released and each cylinder was loaded onto the lifting device and dropped from a height of 8 feet onto a 24" x 24" x ½" thick steel plate on the ground. (The 8 feet is as measured from the valve to the plate on the ground). See results of each test below.

After pressurizing the cylinder to 250 psig, evidence of leak around the thread area was very obvious. I would classify this type of leak as a "bubbler". There was no evidence of Cross-porting or a Safety leak. In addition, there was no evidence of leakage above the diaphragms.

Both cylinder valves showed no visual evidence of metal tearing, although there is definite evidence of metal pulling. Closer evaluation under a microscope should provide more detailed analysis.

could not reach this gross weight full of water so steel shot was used instead to bring the total cylinder weights above 250 lb gross. In addition, we decided to increase the impact by utilizing the higher height of 8 ft as used by some cylinder cap manufacturers. This resulted in a final impact force of two times that of the earlier drop testing.

The test results confirmed the earlier testing and highlighted the differences between stainless alloys. The weaker 303 Stainless cracked at the thread interface in one of the two cylinders dropped while the 316 Stainless both had small leakers (<10 cc/min)⁽⁴⁾

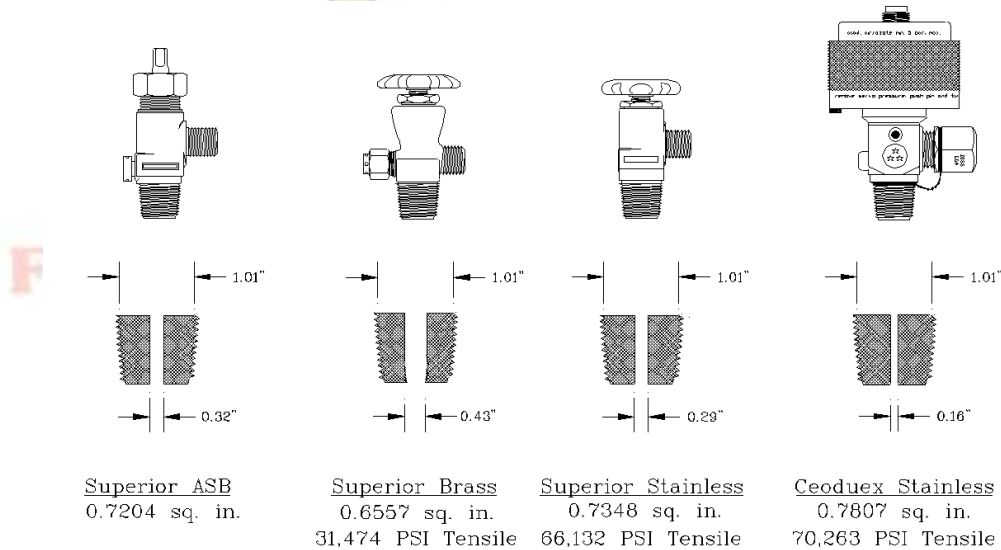
Fig. 21: Valve Cross Section and Tensile Strength

The impact strength of a material is related to brittleness and ductility as well as % elongation. From the table above we can see that as the impact strength increases so does the nickel content. Nickel is known for its ductile characteristics. A correlation between % elongation, impact strength, and nickel can be seen.

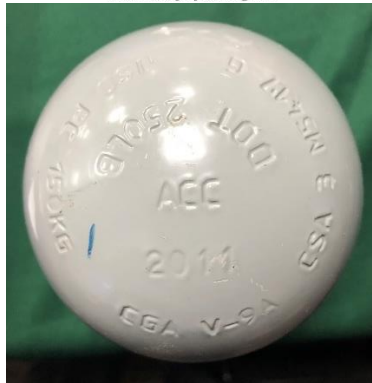
Fig. 22: Cylinder Cap Markings

Caps as a minimum have to be marked with the manufacturer, weight of test, year, etc

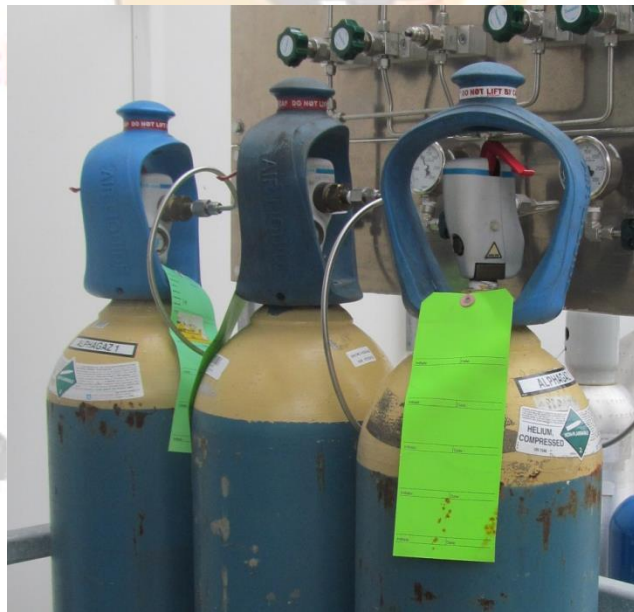
Fig. 23: Air Liquide Plastic Valve Guards

A plastic guard can also be used if it can perform as required. Air Liquide America in 2001 obtained a DOT Exemption E-12782 authorizing their plastic valve guard design to be used for Toxic Zone A & B Gases
