## Anhydrous Hydrogen Chloride

Hydrogen Chloride is a high pressure liquefied gas, toxic and corrosive acid

# Chemically Speaking LLC

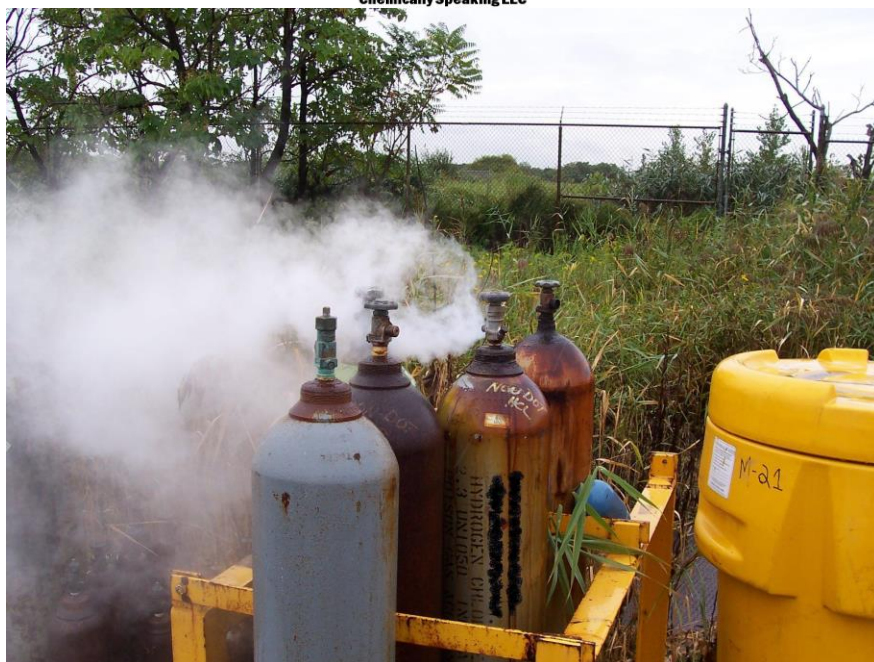
Fig. 1: HCl Cylinder Leak

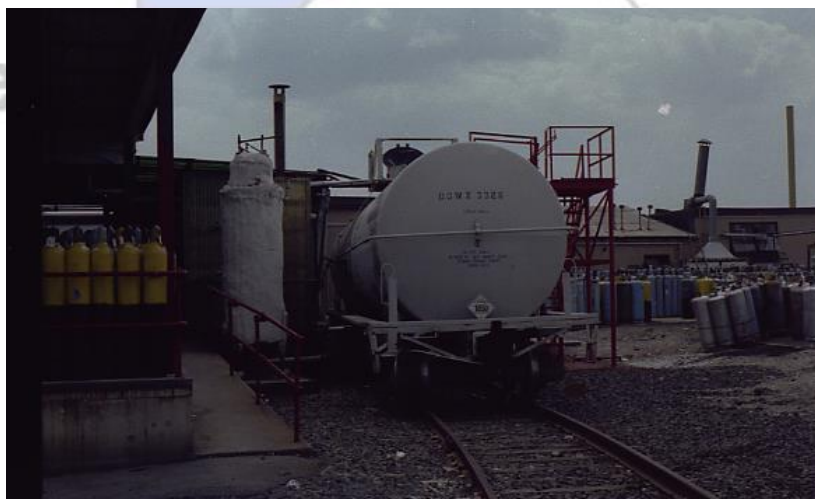
The older railcars (89,000 lbs) had a refrigeration coil in the railcar to cool the liquid HCl to -20°F.

Fig. 2: Older HCl Railcar with Cooling Coil

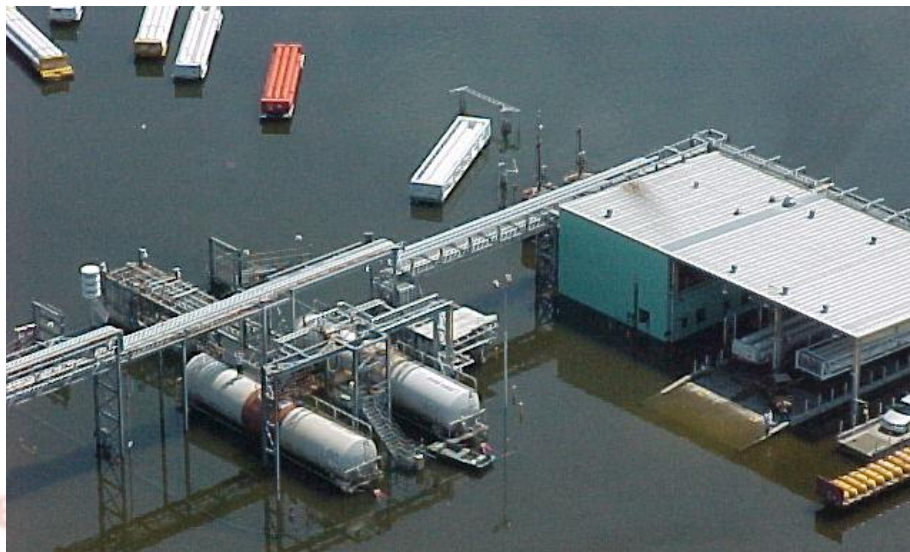
During Katrina (2005) this was not possible at a gas supplier filling facility in New Orleans, LA. Due to flooding electric power was lost for many weeks. This allowed the vapor pressure to build to unsafe levels over many days. The typical pressure relief device has a metal rupture disk that blew at 450 psig into a spring loaded relief valve which reset at 275 psig.

Fig. 3: HCl Railcars In Flood

Periodically workers would row out to the railcars and vent some HCl gas directly into the flood waters to cool the HCl in order to drop the pressure to prevent the pressure relief device from activating and venting the gas into the atmosphere.

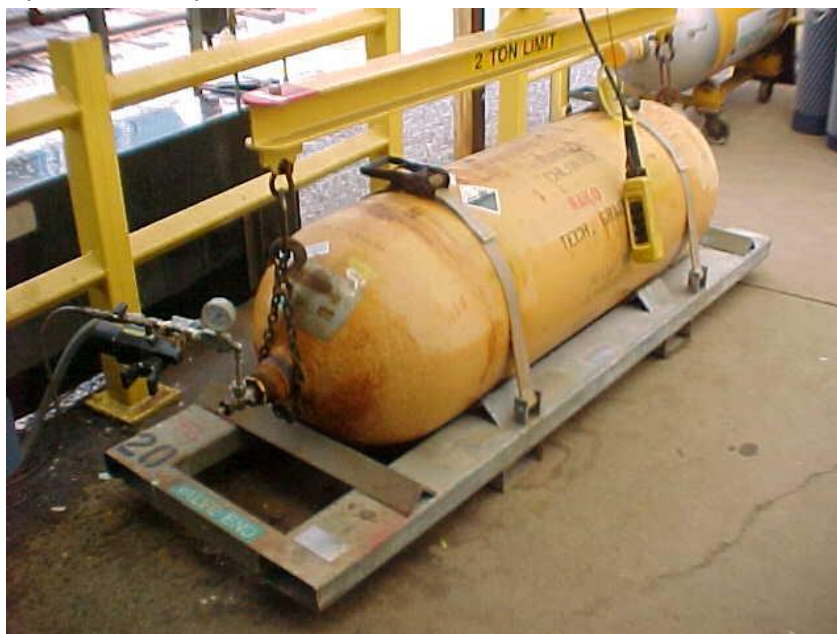
HCl is supplied in cylinders, ton cylinders and tube trailers.

Fig. 4: HCl "Ton" Y Container

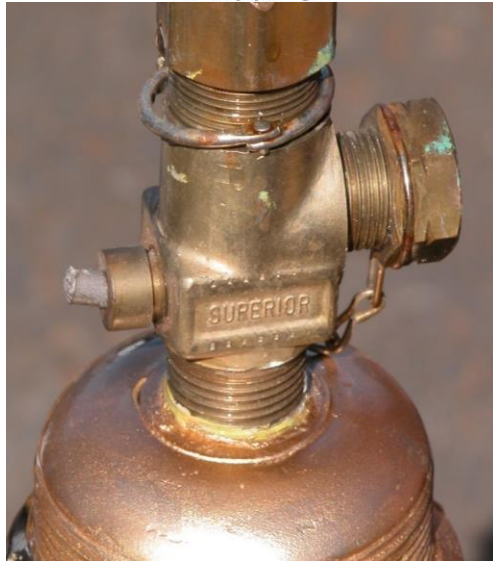
Because of the high vapor pressure, HCl cylinders have a combination pressure relief device, (CG-4) which is a 165°F fuse metal with a metal rupture disk sized for the cylinder pressure rating. In some rare cases the rupture disk might not have sealed properly or is defective exposing the fuse metal to the pressure of HCl. With this high vapor pressure the fuse metal will cold flow until it starts to leak.

Fig. 5: Fuse Metal That Extruded Until the HCl Leaked

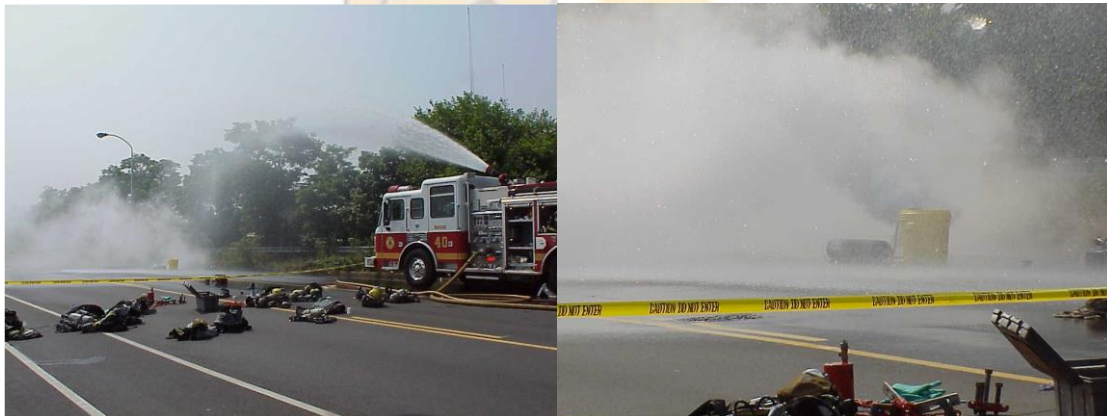
Figs. 6 and 7 : Leaking HCl PRD Fully Activates

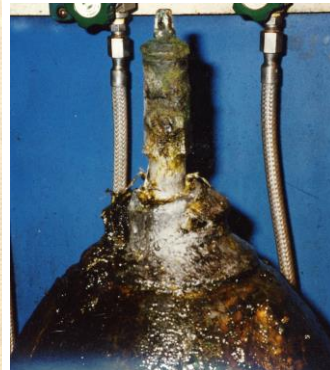
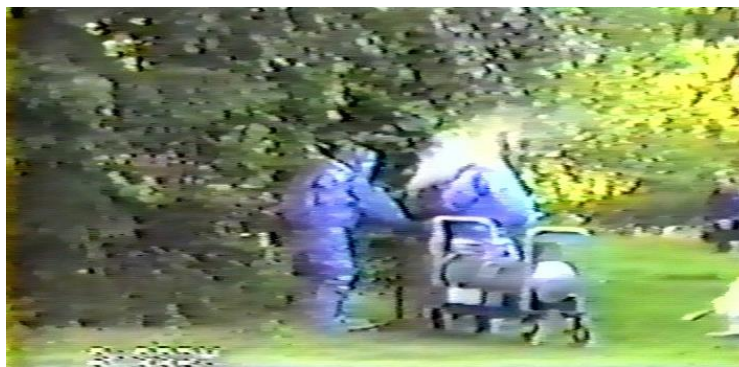
In one incident a HCl Cylinder for unknown reasons was partially buried in a residential yard for years. It started to leak at some point corroding the cylinder and valve over time. It was not until the leak got worse that the homeowner called 911.

Figs 8, 9 and 10: Buried Cylinder Solebury Township, PA

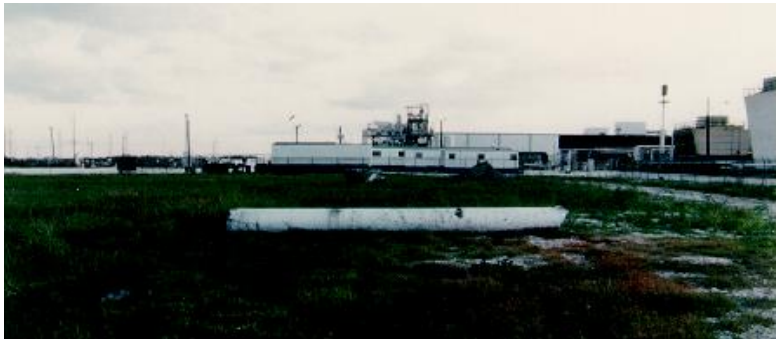
A returned tube trailer was refilled with HCl. The practice was to weigh the tube trailer to determine the amount of residue. This was assumed to be distributed evenly throughout the 8 tubes. It was then filled with cold HCl from a refrigerated railcar. As the HCl warmed up it expanded and the liquid filled a tube causing it to rupture the next morning. No injuries

Fig. 11: Ruptured Tube Flew Over 800 ft

Investigation determined that a tube was contaminated with cotton oil (1650 lbs) at the user site. It was filled with 2,600 lbs of HCl until it stopped flowing. It ruptured at an estimated pressure of 7000 psig, (due to the BLEVE) rapidly expanding liquefied gas tearing the tube into pieces. The tube was torn into two major pieces. The largest section consisting of ~80% of the tube ripped through the bulk head of ½" steel and landed 837 feet away. Trailers are now no longer filled with any residue. They must all be emptied before fill

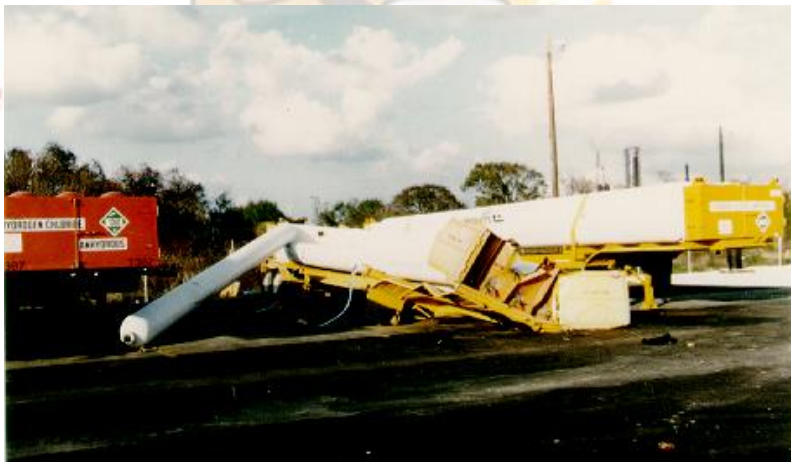
Fig. 12: Tube Trailer With the Adjacent Tube Dislodged

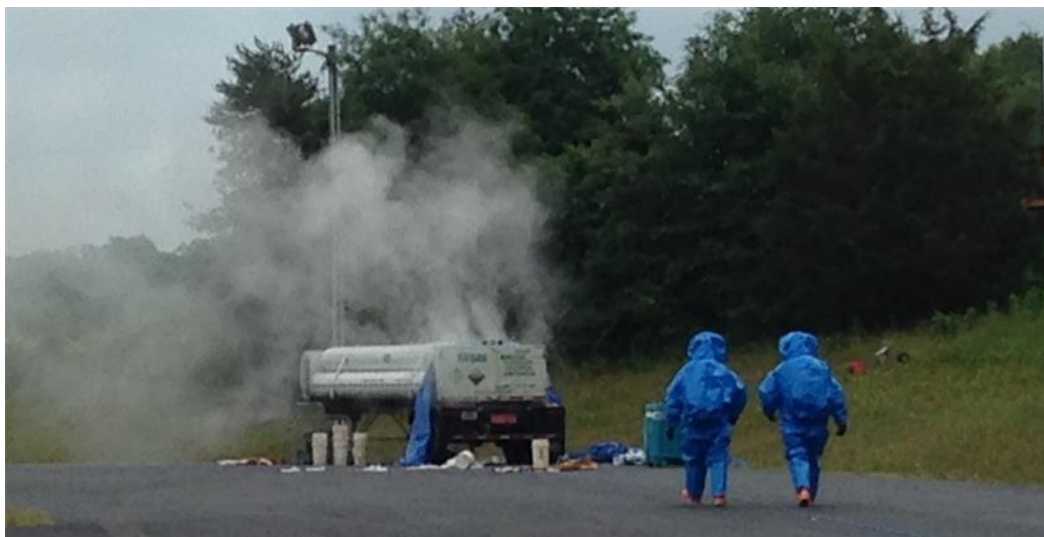
Leaking PRD noted by a driver on Route 85. ER team packed tube with dry ice to cool  
Decision to cold coil transfer into an “empty” trailer. Empty trailer from Texas drove 20 hours to act as a reservoir for cascading the HCl. Dry ice on the tube surface was used to enhance the transfer.

Fig. 13: Leaking Tube Trailer

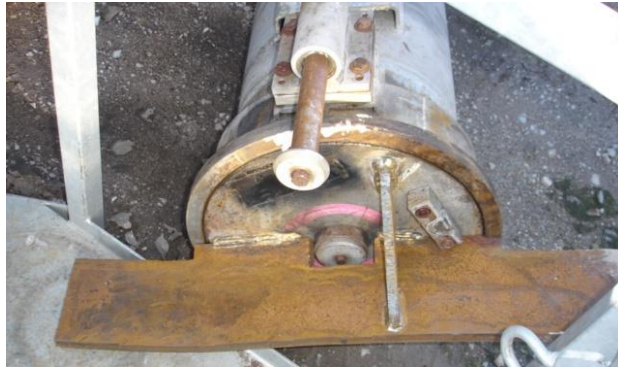
The Sigri ERCV breach closure has proven to be sensitive to HCl corrosion of the threads which causes it to seize and gall shut. At least 3 Sigri ERCV's have been cut apart due to HCl leakage. Making it impossible to open even with plates welded to the door for mechanical leverage.

Fig. 5: Plate Welded Onto Door In Attempt to Open ERCV

Repeated attempts to open the door failed so the ERCV, has to be cut open using a torch or a saw.
