Y Cylinder is a Robust Package

July 2022

To determine if dropping a Y cylinder could cause it to leak. A height of 8 ½ ft was selected since I had authorized 3 high rack storage for them at Air Products.

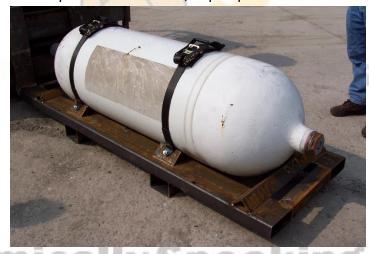
Test Y Cylinder

Manufactured by CPI

Manual Tied Diaphragm 316 ss Ceoduex Valve, 640 DISS

Was fill completely with water to 2393 lbs

New skid with straps that were load rated for 2333 lbs and 3300 lbs with a breaking strength of 10,000 lbs

Changed skid after Test #1

New American Cap used. Replaced after test #3, Cap Impact

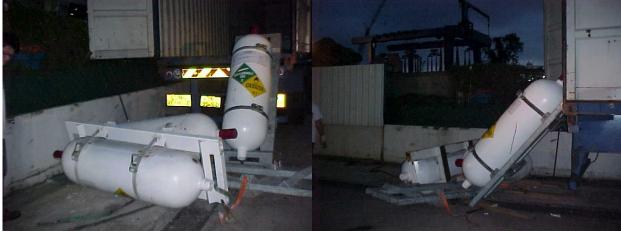
Y Cylinders have been involved in motor vehicle accidents without serious damage or leaks.

A gas supplier forwarded pictures of a NH₃ Y that was in a 40' trailer on a skid. The driver fell asleep and crashed through a guardrail into the side of a canal. The Y crashed through the bulkhead of the trailer through the cab and hit the concrete wall where it ricochets out of the trailer and down the canal embankment. It only suffered minor scratches, no leak.
