Metal Hydride Gas Cylinder Leak Check July 2022

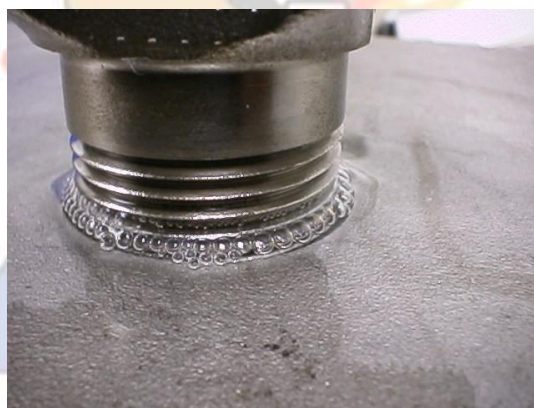
3.2×10^{-5} cc/sec (after 5+ minutes)

To comply with this regulation, the most common leak test method used by compressed gas companies is soap solution which can be sensitive to 10^{-5} cc/sec leak. Note that sensitivity is lower for water soluble gases.

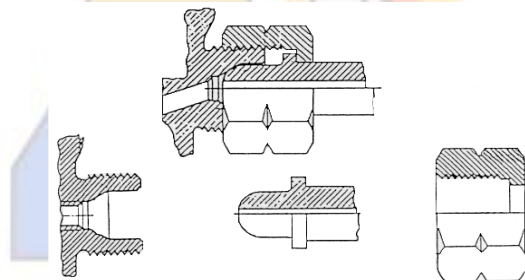
CGA 350 Outlet Connection, Bullet

Metal connections that are repeatedly used such as the standard CGA 350 connection used for Germane or Silane is not capable of routinely providing such a high leak integrity. This bullet connection relies on a nut mechanically compressing a metal nipple into the valve outlet connection. The gas seal is formed by deformation of the nipple and/or outlet connection. The surfaces over time will become scratched and may not be capable of providing a high leak integrity connection. Stainless steel surfaces are more prone to this as they will work harden each time it is deformed, making it more difficult to seal. Leak rates for the connection after repeated use is typically 10^{-5} cc/sec.

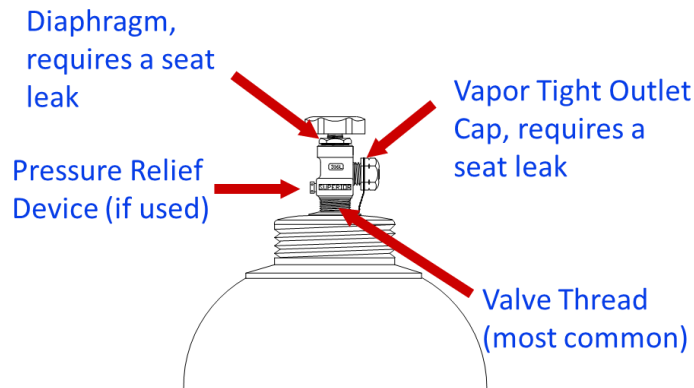
Cylinder leak Points

positioned and held over the leak point for >10 secs. This is difficult to do around the 2 most likely leak points, cylinder valve threads and the valve outlet.

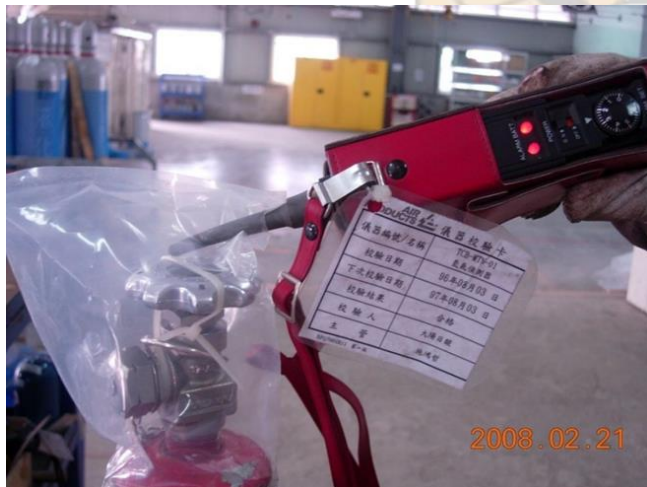
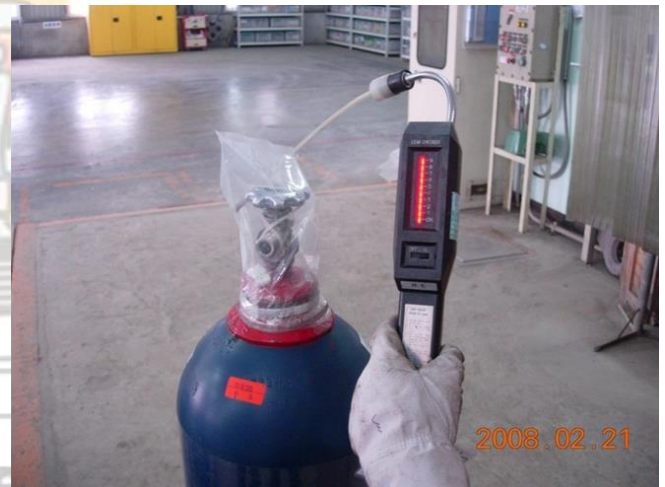
Bagging Cylinder Valves for Leak testing

To assist in this effort, many companies will use a plastic bag to envelop the entire valve to accumulate any leakage over a period of time. This will not only capture the leakage from any point but will also increase the sensitivity.

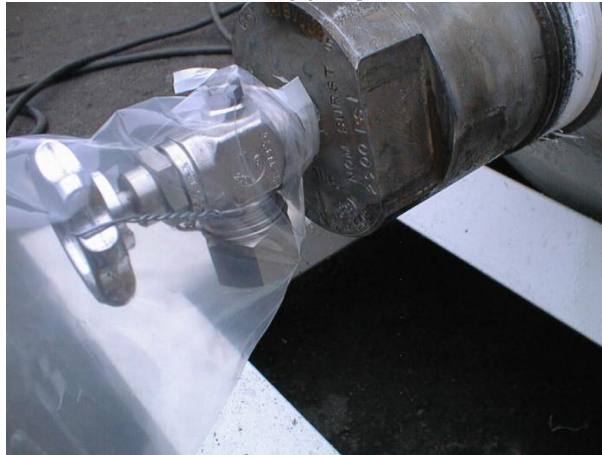
Cylinder Valve Bagged and Wire Shut

To protect the valve from contamination, many gas suppliers will bag the valve. This could accumulate any leakage during transit.

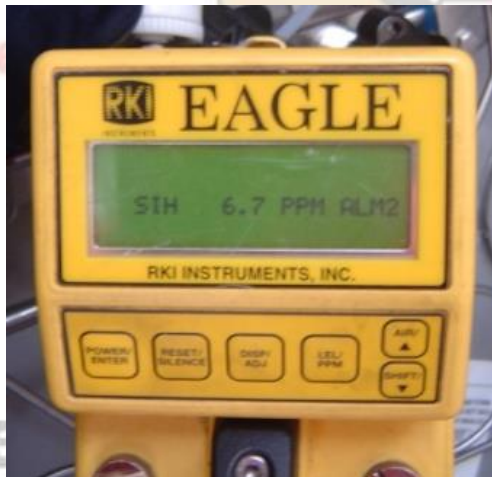
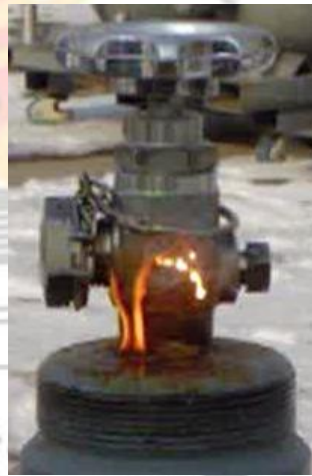
Soap Solution Gathered The Leak Into bubbles that Popped when the Bubble burst

Some leaks will be so small that there will be no visual indication. The silane leak below had no visible indication, white SiO_2 solids or smoke. It was detected during an incoming leak test at 6.7 ppm. To confirm this soap solution was applied to the valve threads. This accumulated the leak into a bubble that burst periodically causing a finger of a flame

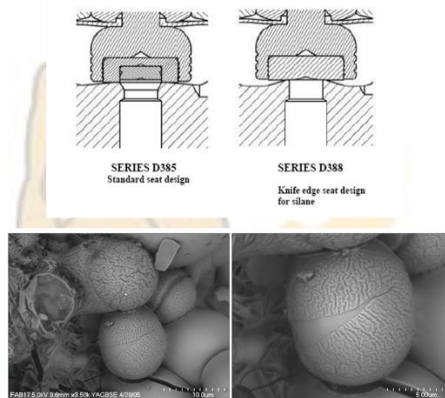
Solids Embedded In Soft valve Seat

React with moisture or oxygen to form solid byproducts which can be trapped under valve seats or sealing surfaces causing small leaks across the seat.

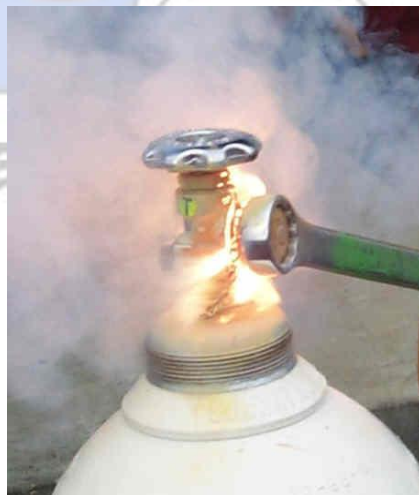
Silane “Popper”

A silane cylinder valve seat with 1×10^{-6} cc/sec seat leakage will pressurize the vaportight outlet cap to 110 psig in 3 months. When the vapor tight cap is loosened this can “pop”

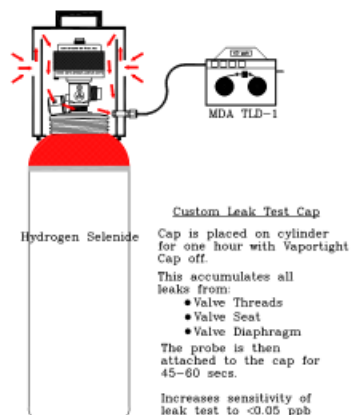
Metal Hydride Gas Leak Check Cap

- Accumulates any leak for 60 minutes which will increase the sensitivity of the leak test from ppt to ppt
- Will detect a leak from any potential leak point
 - Valve Threads
 - Outlet Cap/Valve Seat
 - Valve Diaphragm

After this incident, I designed a metal leak check cap that could be easily placed onto a cylinder. I required that it be used to leak test any metal hydride gas shipment. This was placed on the cylinder with the vaportight cap removed for one hour. The air was then sampled. Any detection was cause for rejection. The arsine cylinder from the incident had a detection of 50 ppb after 30 minutes. It was retained for over 10 years for use as a “calibrated” leaking cylinder and was used to periodically test the method.

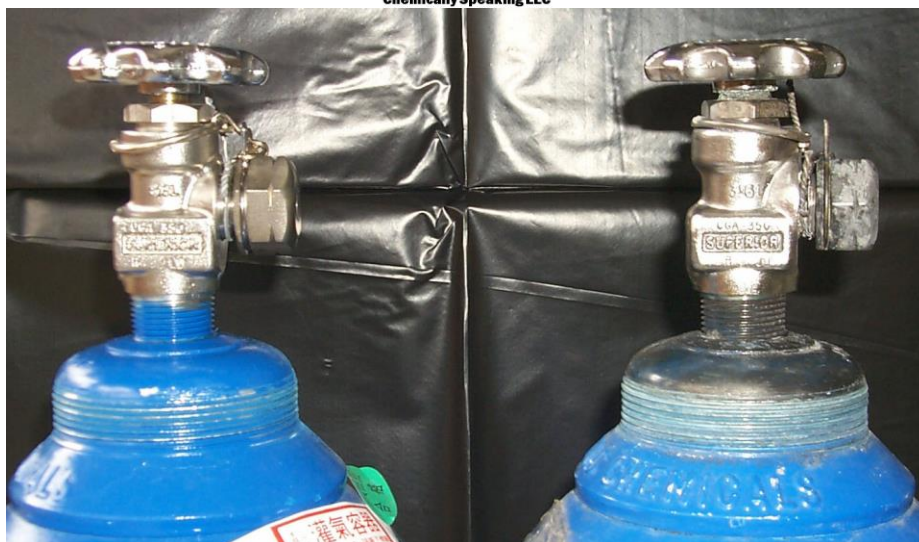
Leak of Arsine over a 3 month period decomposing to Black Arsenic

An ISO container with a group of Arsenic cylinders from Solkatronic arrived in at the distributor in Taiwan in 2000. During their incoming leak testing no leakage was found yet a few cylinder valves and collars were coated with a black deposit (elemental arsenic). Leakage of a small amount of AsH_3 reacted with the moisture in the air decomposing it to elemental arsenic.

The leak check cap was used and after an hour a concentration of 50+ ppb was detected for the cylinders. This triggered an ER which required a US based team to fly to Taiwan and empty the cylinders.

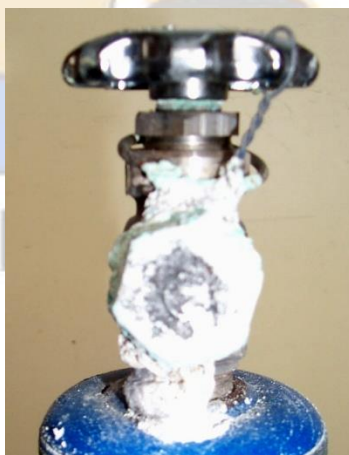
Leak Through Valve Seat and Outlet Cap, 20% AsH_3/H_2 Mixture

Sometimes despite all of the testing, the cylinder can have a delayed leak. The following 20% AsH_3/H_2 mixture valve had a double failure. It leaked across the valve seat and the vaportight cap into the plastic bag. Reaction with the moisture and air formed the yellow solids.
